Manufacturer's Rubber and Supply
Merrimac, MA 01860 (800) 727-7763

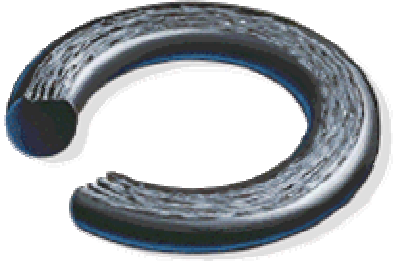
ABRASION

Description: The seal or parts of the seal exhibit a flat surface parallel to the direction or motion. Loose particles and scrapes may be found on the seal surface.

Contributing Factors: Rough sealing surfaces. Excessive temperature. Process environment containing abrasive particles. Dynamic motion. Poor elastomer surface finish.

Suggested Solutions: Use recommended gland surface finishes. Consider internally lubed elastomers. Eliminate abrasive components.

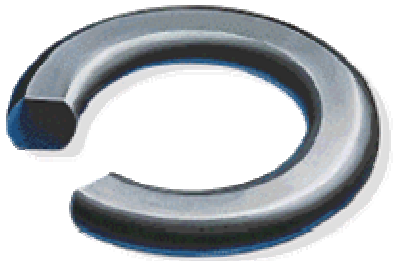
COMPRESSION SET

Description: The seal exhibits a flat-sided cross-section, the flat sides corresponding to the mating seal surfaces.

Contributing Factors: Excessive compression. Excessive temperature. Incompletely cured elastomer. Elastomer with high compression set. Excessive volume swell in chemical.

Suggested Solutions: Low compression set elastomer. Proper gland design for the specific elastomer. Confirm material compatibility.

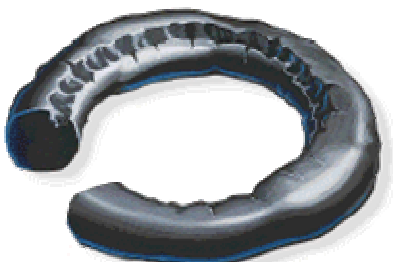
CHEMICAL DEGRADATION

Description: The seal may exhibit many signs of degradation including blisters, cracks, voids or discoloration. In some cases, the degradation is observable only by measurement of physical properties.

Contributing Factors: Incompatibility with the chemical and/or thermal environment.

Suggested Solutions: Selection of more chemically resistant elastomer.

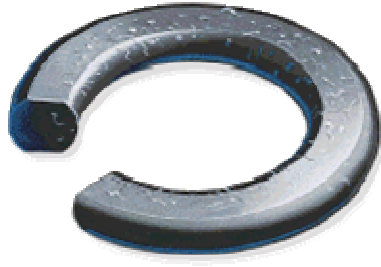
CONTAMINATION

Description: The seal exhibits foreign material on the surface within the cross section.

Contributing Factors: Process environment deposition. Reactions or degradation of the elastomer.

Suggested Solutions: Specify contamination level including manufacturing and packaging of the seals.

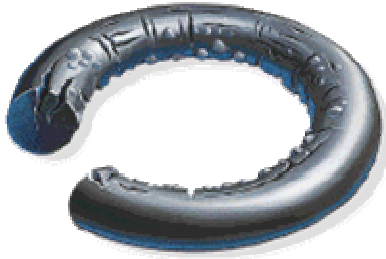
EXPLOSIVE DECOMPRESSION

Description: The seal exhibits blisters, pits or pocks on its surface. Absorption of gas at high pressure and the subsequent rapid decrease in pressure. The absorbed gas blisters and ruptures the elastomer surface as the pressure is rapidly removed.

Contributing Factors: Rapid pressure changes. Low-modulus/hardness elastomer.

Suggested Solutions: Higher-modulus/hardness elastomer. Slower decompression (release of pressure).

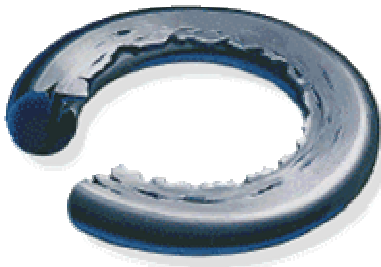
EXTRUSION

Description: The seal develops ragged edges (generally on the low-pressure side) which appear tattered.

Contributing Factors: Excessive clearances. Excessive pressure. Low-modulus/hardness elastomer. Excessive gland fill. Irregular clearance gaps. Sharp gland edges. Improper sizing.

Suggested Solutions: Decrease clearances. Higher-modulus/hardness elastomer. Proper gland design. Use of polymer backup rings.

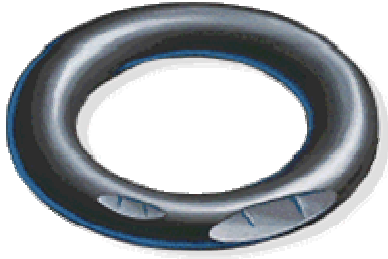
INSTALLATION DAMAGE

Description: The seal or parts of the seal may exhibit small cuts, nicks or gashes.

Contributing Factors: Sharp edges on glands or components. Improper sizing of elastomer. Low-modulus/hardness elastomer. Elastomer surface contamination.

Suggested Solutions: Remove all sharp edges. Proper gland design. Proper elastomer sizing. Higher-modulus/hardness elastomer.

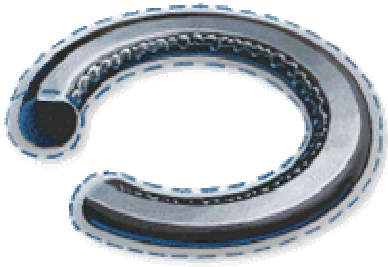
OUTGASSING / EXTRACTION

Description: This failure is often very difficult to detect from examination of the seal. The seal may exhibit a decrease in cross-sectional size.

Contributing Factors: Improper or improperly cured elastomer. High vacuum levels. Low hardness/plasticized elastomer.

Suggested Solutions: Avoid plasticized elastomers. Ensure all seals are properly post-cured to minimize outgassing.

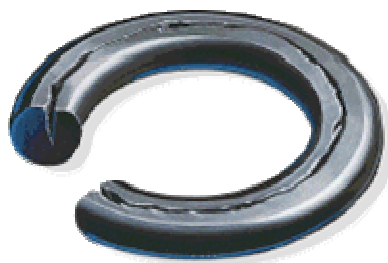
OVERCOMPRESSION

Description: The seal exhibits parallel flat surfaces (corresponding to the contact areas) and may develop circumferential splits within the flattened surfaces.

Contributing Factors: Improper design—failure to account for thermal or chemical volume changes, or excessive compression.

Suggested Solutions: Gland design should take into account material responses to chemical and thermal environments.

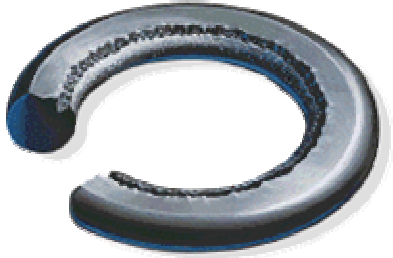
PLASMA DEGRADATION

Description: The seal often exhibits discoloration, as well as powdered residue on the surface and possible erosion of elastomer in the exposed areas.

Contributing Factors: Chemical reactivity of the plasma. Ion bombardment (sputtering). Electron bombardment (heating). Improper gland design. Incompatible seal material.

Suggested Solutions: Plasma-compatible elastomer and compound. Minimize exposed area. Examine gland design.

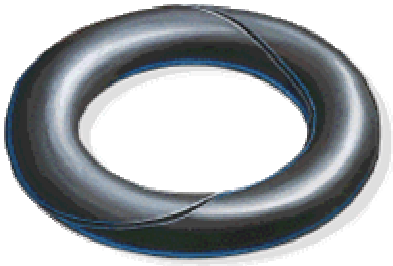
SPIRAL FAILURE

Description: The seal exhibits cuts or marks which spiral around its circumference.

Contributing Factors: Difficult or tight installation (static). Slow reciprocating speed. Low-modulus/hardness elastomer. Irregular O-ring surface finish (including excessive parting line). Excessive gland width. Irregular or rough gland surface finish. Inadequate lubrication.

Suggested Solutions: Correct installation procedures. Higher-modulus elastomer. Internally-lubed elastomers. Proper gland design. Gland surface finish of 8–16 microinch RMS. Possible use of polymer backup rings.

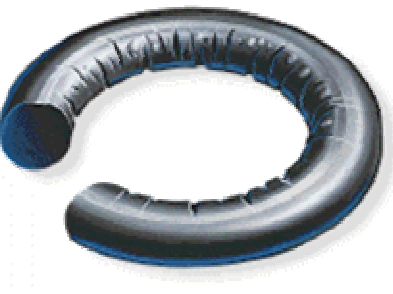
THERMAL DEGRADATION

Description: The seal may exhibit radial cracks located on the highest temperature surfaces. In addition, certain elastomers may exhibit signs of softening—a shiny surface as a result of excessive temperatures.

Contributing Factors: Elastomer thermal properties. Excessive temperature excursions or cycling.

Suggested Solutions: Selection of an elastomer with improved thermal stability. Evaluation of the possibility of cooling sealing surfaces.
