## ABRASION

Manufacturer's Rubber and Supply  
Merrimac, MA 01860 (800) 727-7763

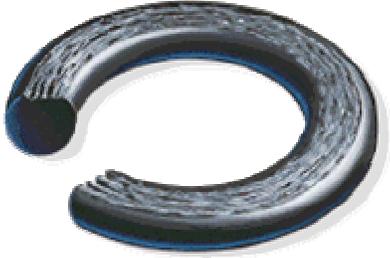
**Description:** The seal or parts of the seal exhibit a flat surface parallel to the direction or motion. Loose particles and scrapes may be found on the seal surface.

**Contributing Factors:** Rough sealing surfaces. Excessive temperature. Process environment containing abrasive particles. Dynamic motion. Poor elastomer surface finish.

**Suggested Solutions:** Use recommended gland surface finishes. Consider internally lubed elastomers. Eliminate abrasive components.

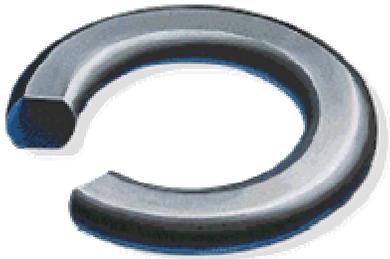
## COMPRESSION SET

**Description:** The seal exhibits a flat-sided cross-section, the flat sides corresponding to the mating seal surfaces.

**Contributing Factors:** Excessive compression. Excessive temperature. Incompletely cured elastomer. Elastomer with high compression set. Excessive volume swell in chemical.

**Suggested Solutions:** Low compression set elastomer. Proper gland design for the specific elastomer. Confirm material compatibility.

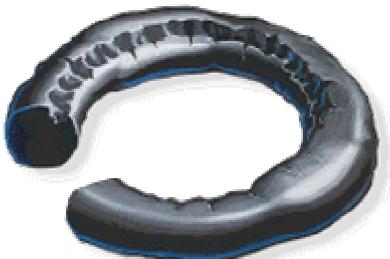
## CHEMICAL DEGRADATION

**Description:** The seal may exhibit many signs of degradation including blisters, cracks, voids or discoloration. In some cases, the degradation is observable only by measurement of physical properties.

**Contributing Factors:** Incompatibility with the chemical and/or thermal environment.

**Suggested Solutions:** Selection of more chemically resistant elastomer.

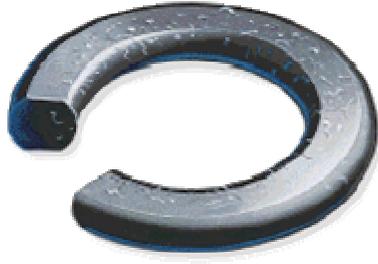
## CONTAMINATION

**Description:** The seal exhibits foreign material on the surface within the cross section.

**Contributing Factors:** Process environment deposition. Reactions or degradation of the elastomer.

**Suggested Solutions:** Specify contamination level including manufacturing and packaging of the seals.

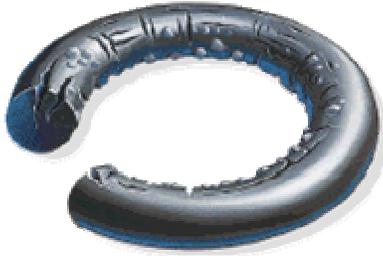
## EXPLOSIVE DECOMPRESSION

**Description:** The seal exhibits blisters, pits or pocks on its surface. Absorption of gas at high pressure and the subsequent rapid decrease in pressure. The absorbed gas blisters and ruptures the elastomer surface as the pressure is rapidly removed.

**Contributing Factors:** Rapid pressure changes. Low-modulus/hardness elastomer.

**Suggested Solutions:** Higher-modulus/hardness elastomer. Slower decompression (release of pressure).

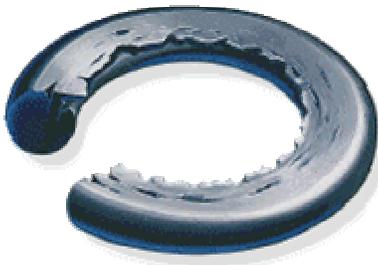
## EXTRUSION

**Description:** The seal develops ragged edges (generally on the low-pressure side) which appear tattered.

**Contributing Factors:** Excessive clearances. Excessive pressure. Low-modulus/hardness elastomer. Excessive gland fill. Irregular clearance gaps. Sharp gland edges. Improper sizing.

**Suggested Solutions:** Decrease clearances. Higher-modulus/hardness elastomer. Proper gland design. Use of polymer backup rings.

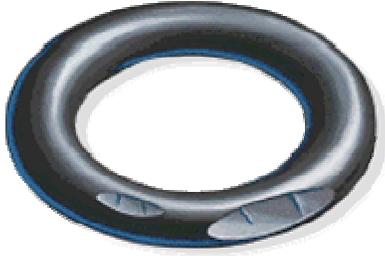
## INSTALLATION DAMAGE

**Description:** The seal or parts of the seal may exhibit small cuts, nicks or gashes.

**Contributing Factors:** Sharp edges on glands or components. Improper sizing of elastomer. Low-modulus/hardness elastomer. Elastomer surface contamination.

**Suggested Solutions:** Remove all sharp edges. Proper gland design. Proper elastomer sizing. Higher-modulus/hardness elastomer.

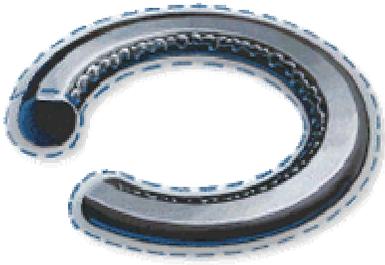
## OUTGASSING / EXTRACTION

**Description:** This failure is often very difficult to detect from examination of the seal. The seal may exhibit a decrease in cross-sectional size.

**Contributing Factors:** Improper or improperly cured elastomer. High vacuum levels. Low hardness/plasticized elastomer.

**Suggested Solutions:** Avoid plasticized elastomers. Ensure all seals are properly post-cured to minimize outgassing.

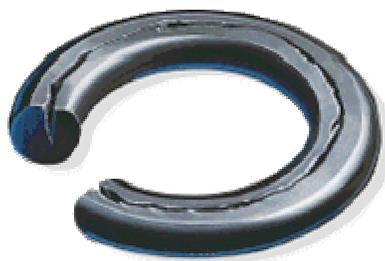
## OVERCOMPRESSION

**Description:** The seal exhibits parallel flat surfaces (corresponding to the contact areas) and may develop circumferential splits within the flattened surfaces.

**Contributing Factors:** Improper design—failure to account for thermal or chemical volume changes, or excessive compression.

**Suggested Solutions:** Gland design should take into account material responses to chemical and thermal environments.

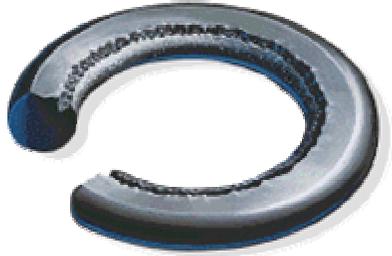
## PLASMA DEGRADATION

**Description:** The seal often exhibits discoloration, as well as powdered residue on the surface and possible erosion of elastomer in the exposed areas.

**Contributing Factors:** Chemical reactivity of the plasma. Ion bombardment (sputtering). Electron bombardment (heating). Improper gland design. Incompatible seal material.

**Suggested Solutions:** Plasma-compatible elastomer and compound. Minimize exposed area. Examine gland design.

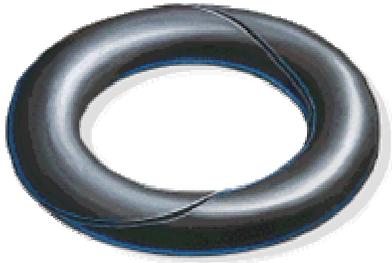
## SPIRAL FAILURE

**Description:** The seal exhibits cuts or marks which spiral around its circumference.

**Contributing Factors:** Difficult or tight installation (static). Slow reciprocating speed. Low-modulus/hardness elastomer. Irregular O-ring surface finish (including excessive parting line). Excessive gland width. Irregular or rough gland surface finish. Inadequate lubrication.

**Suggested Solutions:** Correct installation procedures. Higher-modulus elastomer. Internally-lubed elastomers. Proper gland design. Gland surface finish of 8–16 microinch RMS. Possible use of polymer backup rings.

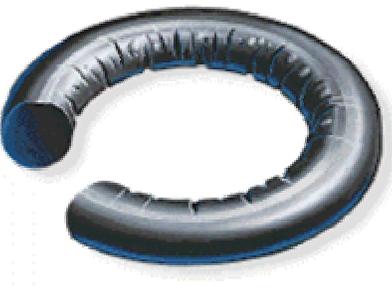
## THERMAL DEGRADATION

**Description:** The seal may exhibit radial cracks located on the highest temperature surfaces. In addition, certain elastomers may exhibit signs of softening—a shiny surface as a result of excessive temperatures.

**Contributing Factors:** Elastomer thermal properties. Excessive temperature excursions or cycling.

**Suggested Solutions:** Selection of an elastomer with improved thermal stability. Evaluation of the possibility of cooling sealing surfaces.
